**Client:** Paul Tziouvaras  
**Inspection Address:** 5331 Paseo Orlando, Santa Barbara, CA  
**Inspection Date:** 8/26/2009 Start: 9:30 am End: 12:30 pm

## HOME INSPECTION REPORT

For the property located at  
**5331 Paseo Orlando, Santa Barbara, CA**

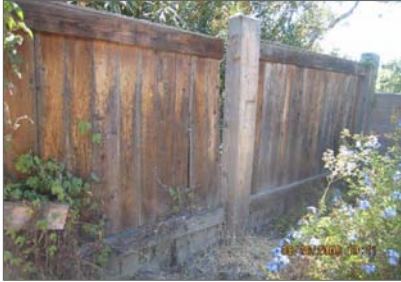
- 1.1 - Sections of the fence are leaning or damaged and should be repaired or replaced.

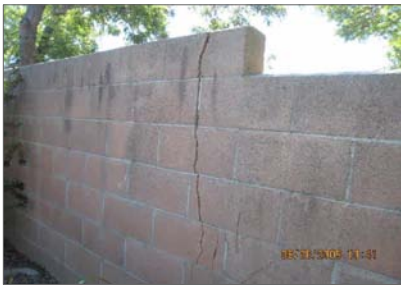
- 1.3 - The cinder block yard walls at the south yard has stress fractures and is leaning and should be evaluated by an appropriate specialist for further remarks and recommendations.

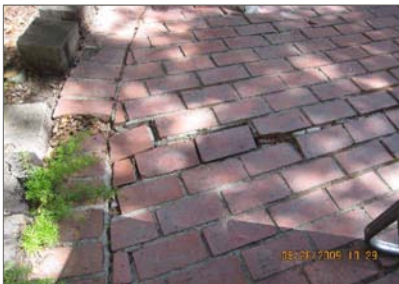
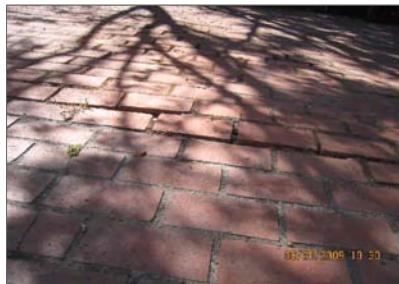
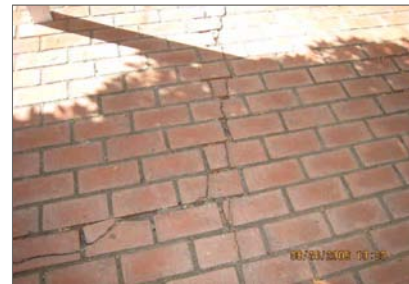
1.12 - There are offsets in the south brick patio that could prove to be trip-hazards that you should have repaired/services for safety reasons. Numerous cracked brick were noted.

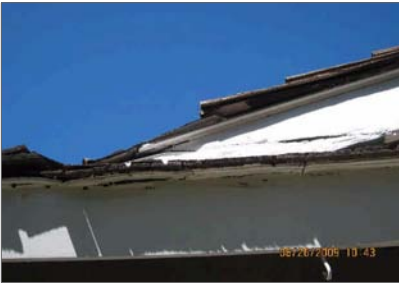
2.2 - A pest control inspection and report should confirm damage/decay to significant portions of the fascia board and wood trim and the need/cost for replacement/repair.

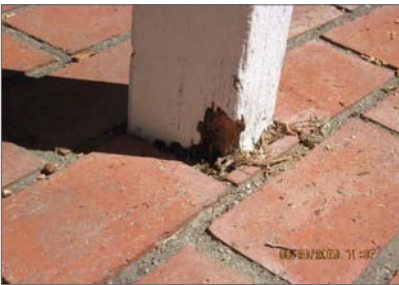
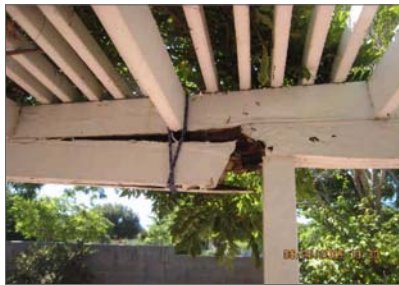
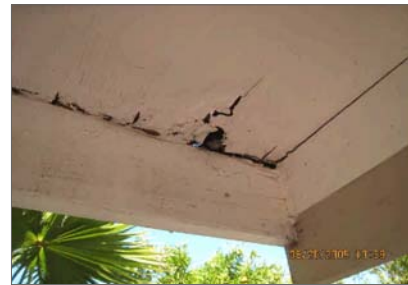
2.7 - A pest control inspection and report should confirm damage to portions of the wood patio cover and the need for replacement/repair.

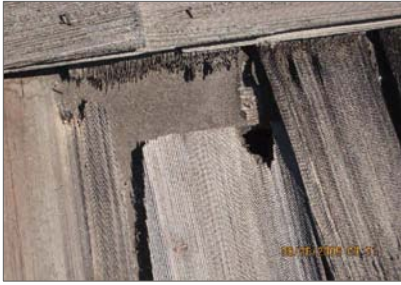
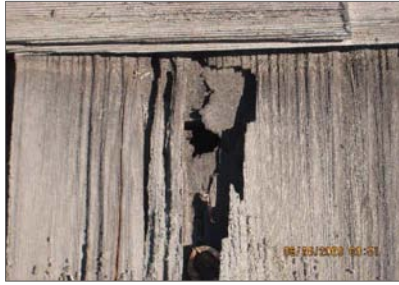
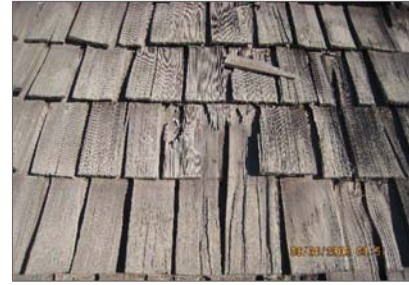
4.2 - The older, original wood shake roof covering is approximately 30 years old and will leak, which can be confirmed by clearly visible points of light from within the attic. This may not yet be apparent within the house, because what moisture penetrates can be absorbed by the insulation on the floor of the attic. However, the roof should be evaluated by an appropriately qualified roofing contractor before the close of this transaction, because the cost of replacing it could affect your evaluation of the property, and because replacement appears necessary.

The older wood shake roof covering is original and in poor condition and will leak - *Continued*

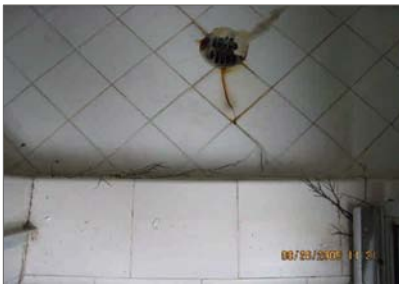
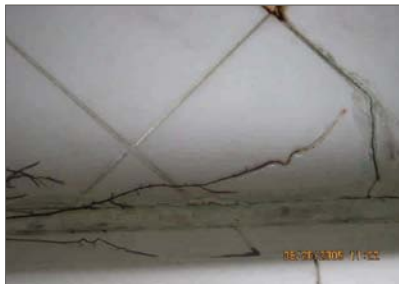
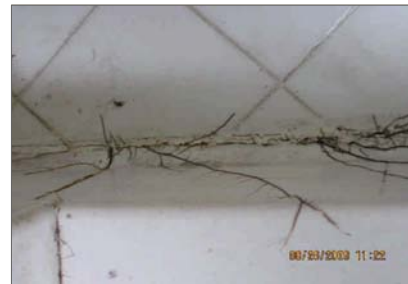
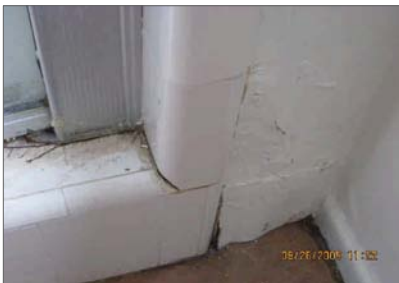
6.20 - The shower pan in the master bathroom shower stall appears to be leaking and should be evaluated by an appropriately qualified and licensed plumbing contractor for further remarks and recommendations. There are multiple cracked tile and roots growing through the tile. Water damaged drywall was observed at/around the shower stall.

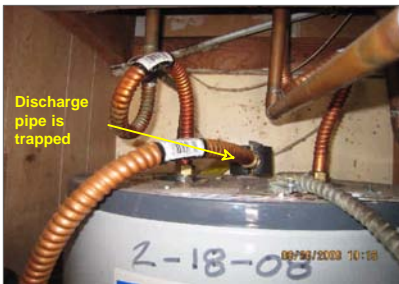
6.33 - The discharge line from the T&P relief valve on the water heater has been incorrectly plumbed uphill, and the line should slope downhill to ensure that any leakage from the valve does not remain in the "trapped" drain line, as this condition can lead to corrosion and failure of the valve.

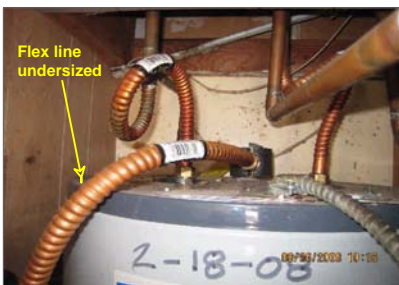
6.34 - The flexible discharge pipe from the pressure relief valve on the water heater is undersized (the entire line should be the same size as the valve opening) and needs replacing with a correctly sized pipe for safety.

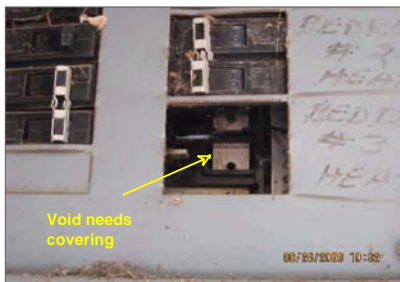
7.7 - There are voids, or open knockouts, in the interior "deadfront" cover of the main electrical panel that should be covered for safety (children or the unknowing can open the panel covers and expose themselves to a shock hazard). However, this condition is very easily remedied and at minimal expense.

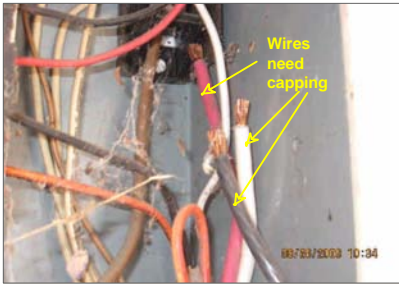
7.8 - There are wires inside the main panel that need to be capped. This will help prevent them from becoming accidentally energized.

There are wires inside the main panel that need to be capped - *Continued*

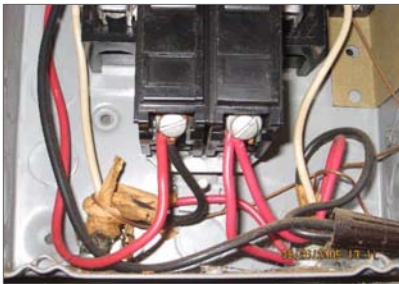
7.12 - The two breakers in the sub-panel are serving more than one circuit, which could overload the circuits, and there is not room within the sub-panel to add additional breakers. This condition should be evaluated by an electrician.

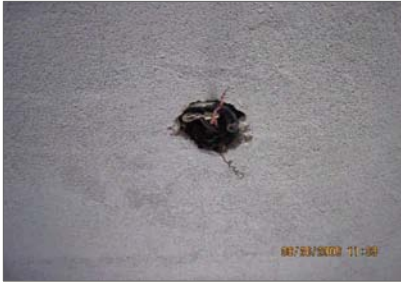
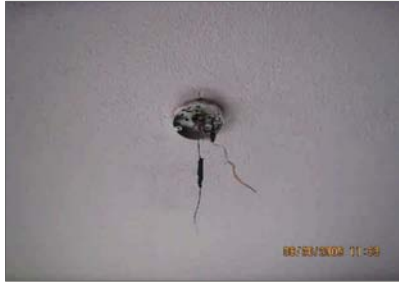
7.22 - We noted that there are missing light fixtures in the entry hallway and dining room that will need to be replaced.

There were multiple missing light fixtures - *Continued*

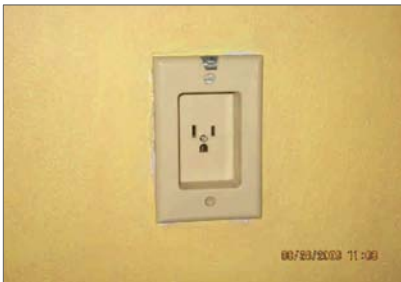
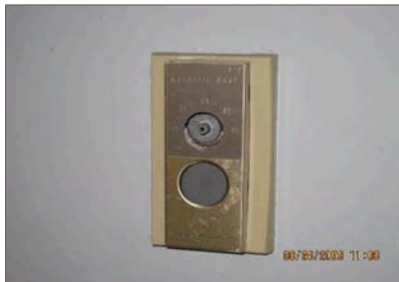
8.1 - Heat is provided by a electric radiant heating system that we do not have the expertise to evaluate and falls outside the scope of a home inspection and this report. However, we recommend that you have the system evaluated by an appropriately qualified and licensed heating specialist before the close of the transaction. Please note that these systems are not energy efficient and can be expensive to operate. Many of the controls are missing/damaged and need to be replaced if the system is found to be functional and is to remain in use.

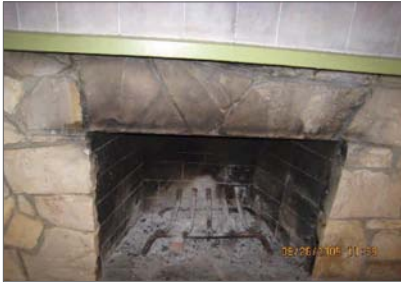
9.2 - This fireplace appears to have a smoking condition, as indicated by the smoke patterns located above the fireplace opening. Dangerous gases have been exiting the fireplace into the living area. This is

considered a potential health hazard. The exact cause of this condition is unknown but may be due to an undersized flue, defective construction, backdrafting from pressure changes within the home and/or improper use of the damper. We recommend that you do not operate this fireplace until this condition has been evaluated and corrected by a qualified fireplace specialist.

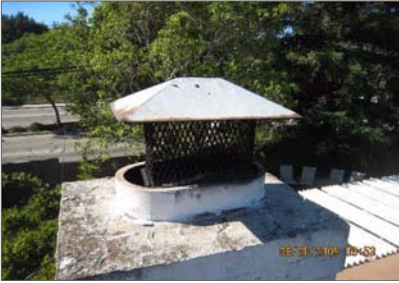
9.13 - A combination spark arrestor and weather cap assembly was in place at the top of the chimney but is undersized and partially blocking the flue. Replacement with a properly sized cap/arrestor assembly is advised.

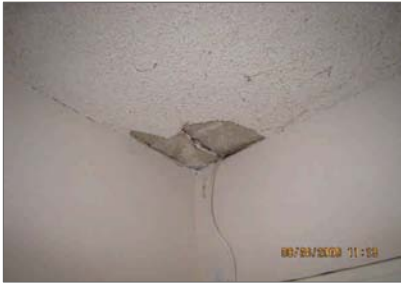
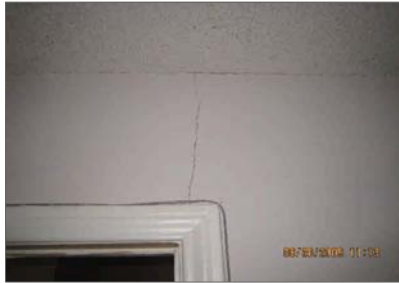
10.5 - The wall and ceiling coverings need some maintenance type repairs, such as patching holes and cracks, painting, etc.

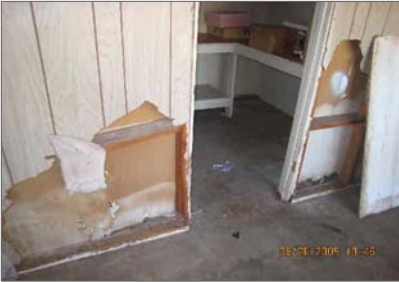
11.6 - The drywall covering at the south room addition walls is heavily damaged.

The drywall covering at the east wall is damaged and you may wish to have it repaired - *Continued*

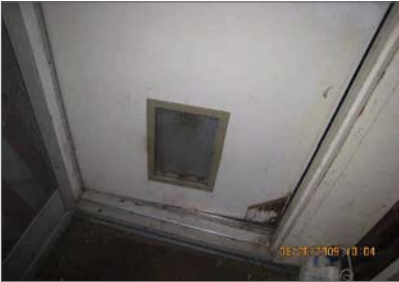
11.7 - The interior door accessing the garage appears to be solid core, or fire-rated as required to maintain the fire separation barrier between the living areas of the home and garage. However, the door has been compromised by the addition of a pet door that negates its fire rating, and it will need to be replaced with a tight fitting, self-closing, self-latching fire door for fire safety.
